# CONDITION SURVEY OF LOCK NO. 7, MONONGAHELA RIVER

May 1987  
Final Report

Prepared for US Army Engineer District, Pittsburgh  
Pittsburgh, Pennsylvania 15222-4186

CONDITION SURVEY OF LOCK NO. 7,  
MONONGAHELA RIVER

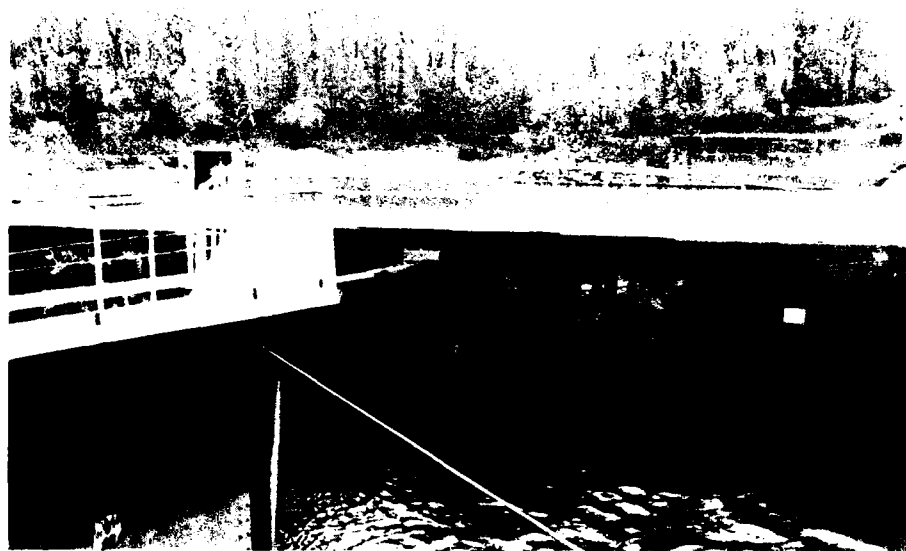
#### Miter Gate Recesses

a. Lower miter gate recess, river wall

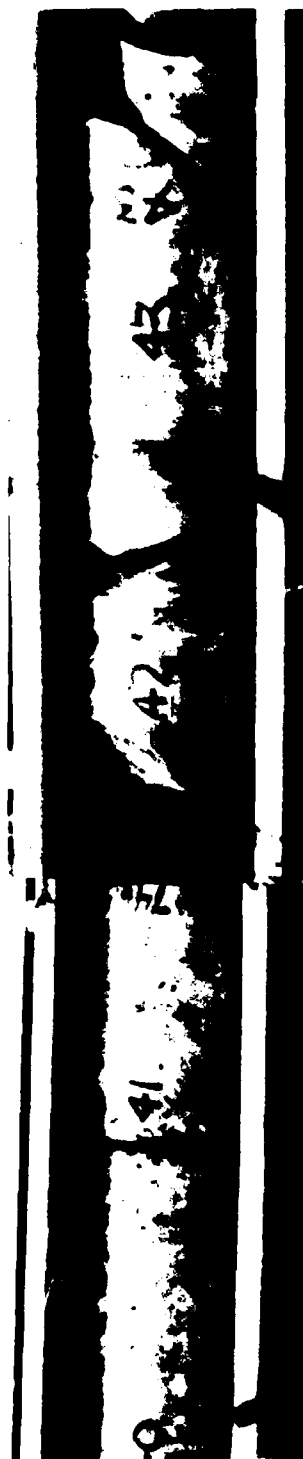
a. Concrete/foundation rock contact (loose bond), boring R-1-82 in river lock wall upper miter gate monolith block. Depth 40.0 to 43.6 ft

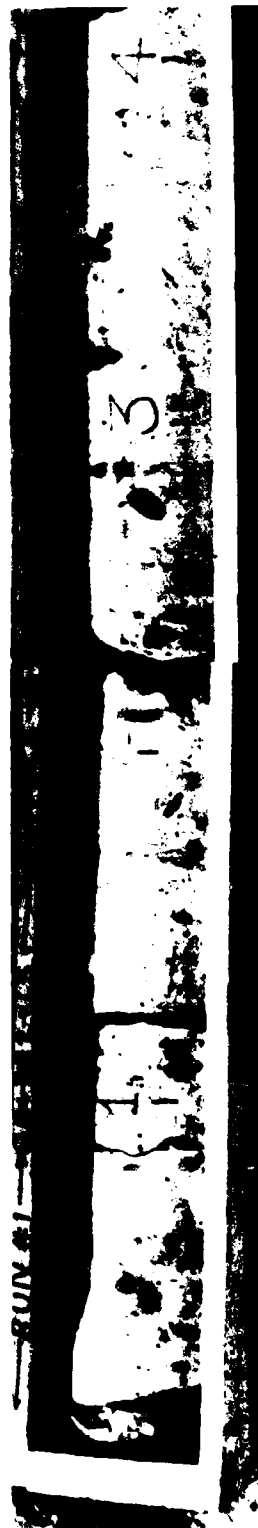
Concrete core, vertical boring R-2-82 in upper guard wall,  
0.0-0.1' damaged zone

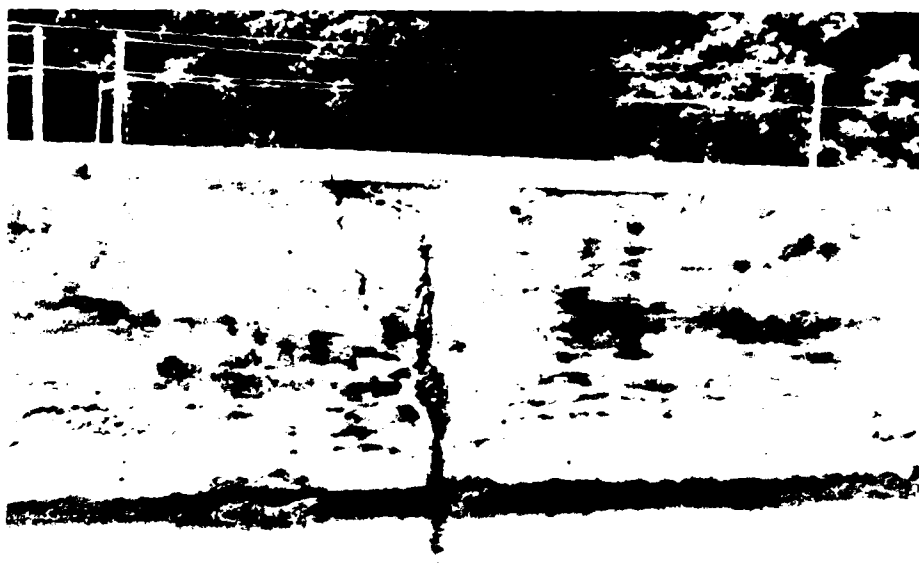
7. The vertical face of the wall concrete is in poor condition; it is badly gouged, contains small to large spalls and local severe scaled areas. One to two vertical cracks (wide) are present in each monolith. There are some large joint spalls at the monolith joints.

Photo 4. Typical vertical surface chamber side of upper guide wall, large monolith joint spall, horizontal construction joint is spalled, and erosion near waterline
